**FAILURE INVESTIGATION OF BELL 412 MAIN ROTOR
BLADE TRIM TABS AND STUDY OF SUITABLE ADHESIVE
MATERIAL APPLICATION WITH A NEW TRIM TAB
DESIGN**

Degree of Master of Science

University of Moratuwa

October 2020

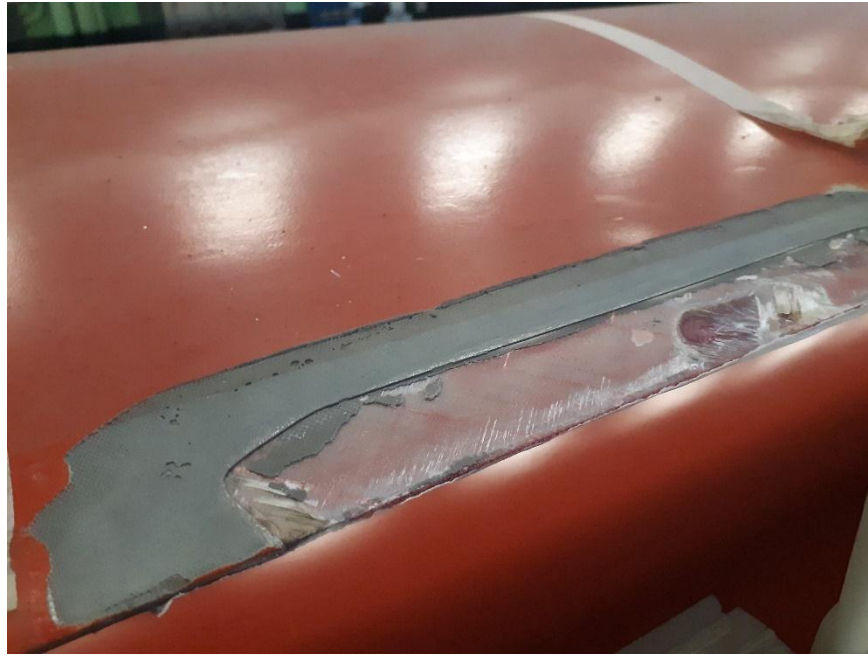
Figure 4: Removed tab of a de-bonded tab

After observation of such conditions, it is noted that this is characterized by adhesive edge crack and results in further damages. As per the OEM's directives in accordance to this condition, the tab is to be replaced. During the taping test, some MRBs generate a unique dull sound stemming from the trim tab areas and on such occasions, blades are inspected thoroughly to identify the failure. These failures could be indicative of de-bonds failure occurring on the glass fibre blade surface or de-bonding between the blade and the trim tab. Figure 4 shows the surface of blade after the removal of the trim tab due to the de-bond on the same.

This is the most severe damage which can be found on the MRBs. Because of this condition, the paper honeycomb is affected and ultimately the structural integrity of the MRB will be distorted. The root cause for this is mainly due to an unidentified de-bonding area of the trim tabs. In such situations, the blades are rendered completely unusable.

crew. At present, the only maintenance action which is undertaken is the replacement of tabs after the observation of such incidents. To circumvent these issues, action has been taken and present remedial measure are taken in to account as a reference guideline.

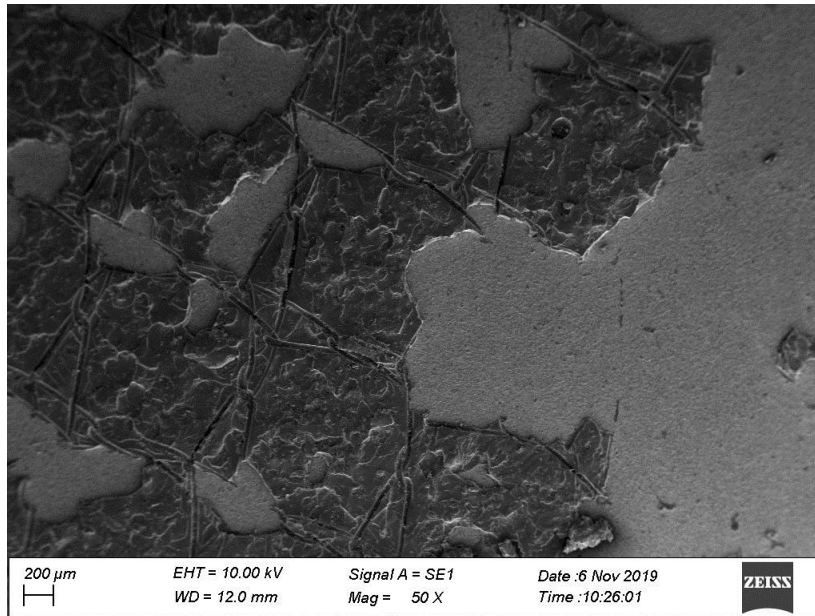
Figure 16: SEM fracture initiation surfaces of the trim tab (50X)

A failed corner edge of the trim was subjected to a fractography analysis. The analysis consisted of visual observation on the exposed fracture surfaces and selected areas of interest were inspected using optical microscopy. finally, the fracture surfaces were characterized using Scanning Electron Microscope (SEM). During the SEM inspection of 50x, 250x and 1000x magnification, the obtained images are as follows.

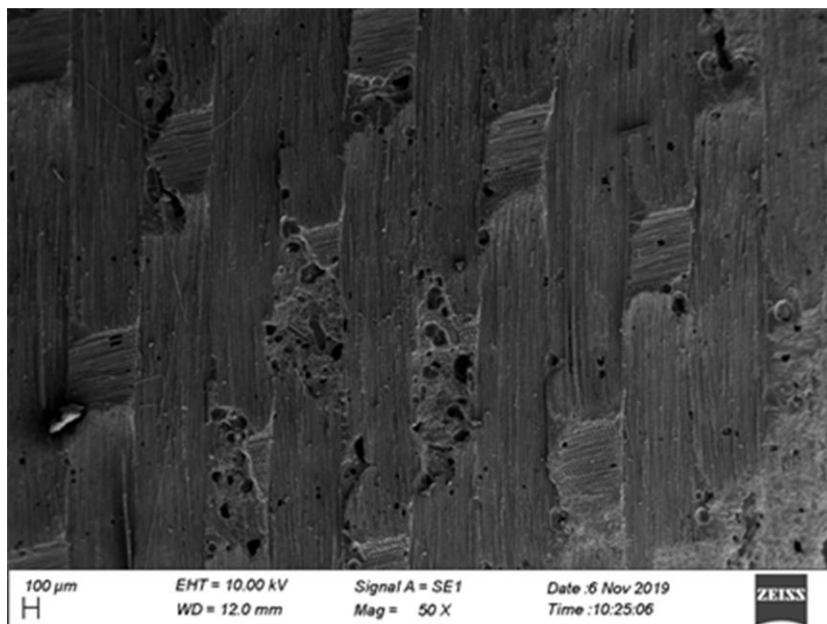
Figure 19: SEM fracture surface of film adhesive (50X)

An analysis was further carried out to inspect the peeled surface of tab which was formed by peeling off manually. This is a layer of film adhesive which was presented at both removed metal surfaces. The purpose of this was to have an idea about the adhesion properties of film adhesive which has shown a great adhesive bonding strength as per past experiences.

As per the fractography analysis, it can be clearly seen that film adhesive has good adhesion properties with the metal surface, since the failure is cohesive within the adhesive material itself and not at the metal and adhesive interface.

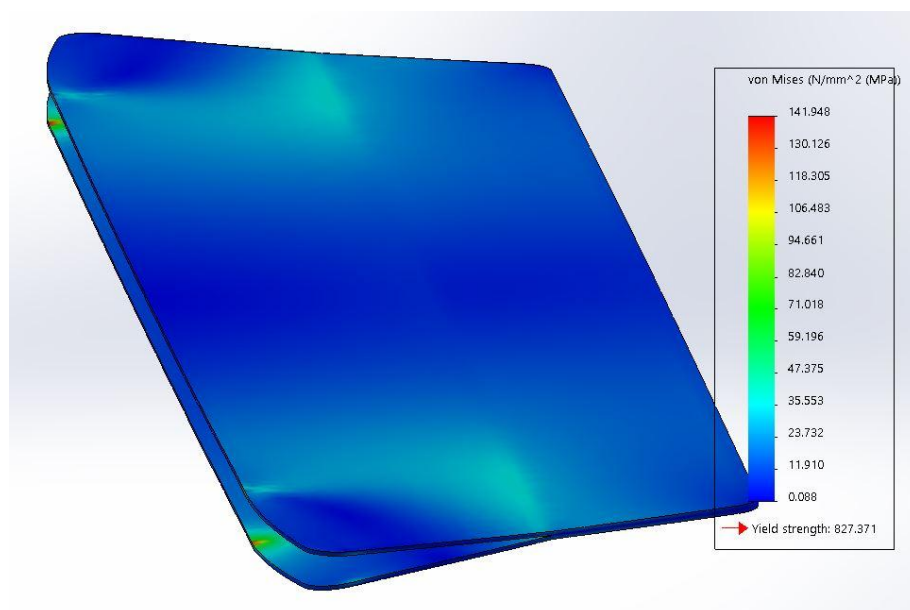
Figure 22: Stress distribution on the trim tab

- b. When a trim tab failure was observed, it is noted that it began from the periphery, developing gradually to the inside of the blade. On inspecting the edges, this investigation revealed an adhesive failure on the trim tab surface. The same surface was subjected to a SEM analysis where the results confirmed that this is a failure of the adhesive. Further, the results obtained from the CFD analysis also confirmed that stress distribution was more pronounced at the periphery.

- c. According to the stress distribution data, it is observed that two points on the leading edge of the tab have high-stress concentration and these areas directly affect the initial de-bonding of the tab. Further, as per past records, it was found that initiation of the de-bonding starts at the corner edges of the tab and subsequently develops to the surrounding areas on it. Therefore, this design is critical to the failure of the tab on the blade.

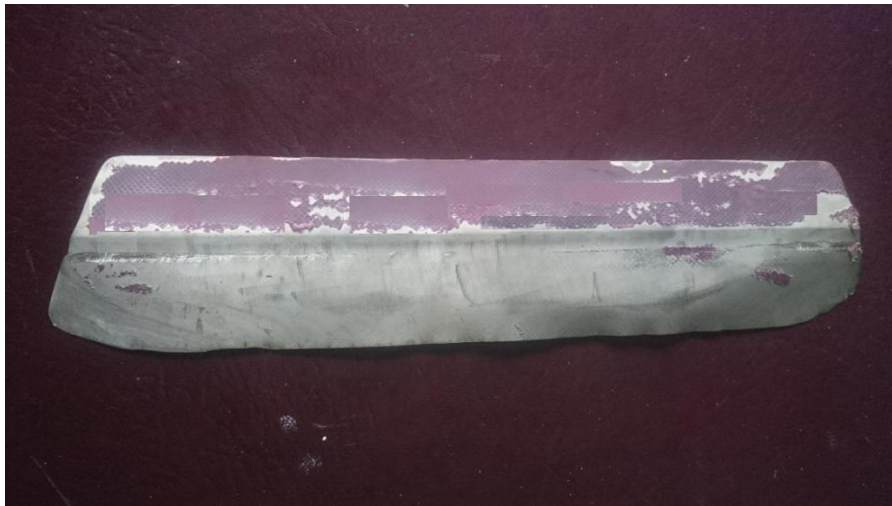
Figure 23: Peeled off tab piece

The root causes for the failure of trim tabs were mainly two loads which can be considered as aerodynamic loads and tab adjustment loads which are applied on the ground. Aerodynamic loads were simulated using software simulation and as per the results, significant loads are applied on the three tabs. According to the results obtained, the inboard tab is subjected to the lowest load and outboard tab was subjected to the highest load. When the tab increased its angle, the load on the tab further increased. As per simulated results, the load on the tab is applied in a downward direction and it affects the tab's removal at the edges. Further, during ground adjustments of the tab, nearly 10 N was applied on the tab to bend them to desired angles. As per load on the tabs, they underwent a fatigue loading condition and the failure of the trim tab is then initiated.

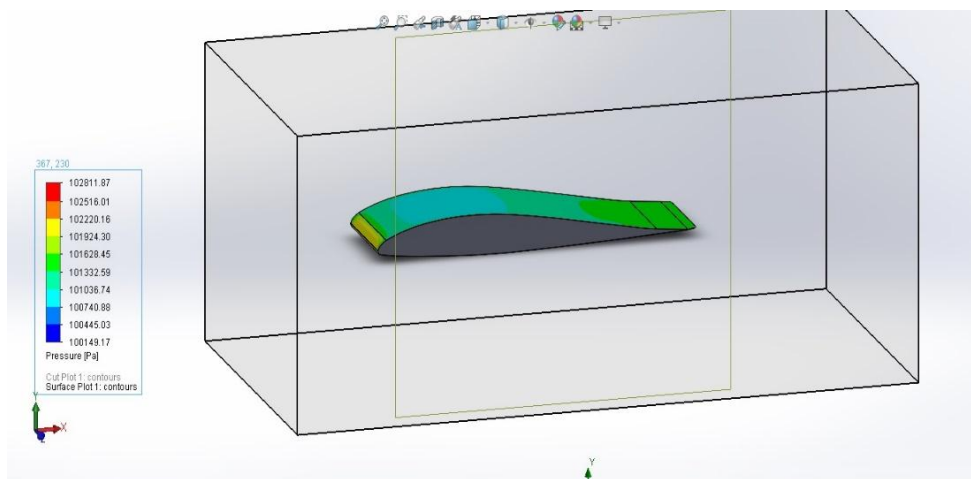
Figure 24: Stress distribution over the tab surface station No 01

As per simulated results based on the trim tab design on the blade, stress areas are shown as following and the highest stress is governed by the outboard tab and lower at the inboard tab. Therefore, there is a high probability of failure occurring at the outboard tab and the least probability of failure, at the inboard tab.

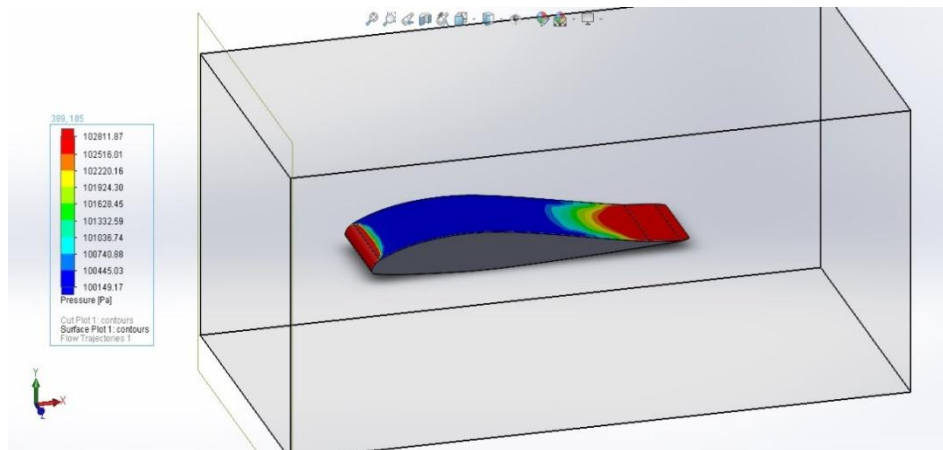
Figure 28: stress distribution over the tab station no. 03

According to the stress distribution findings, maximum stresses applied on the trim tab is higher than the bonding strength results obtained from the floating roller peel test. Therefore, there is a great possibility of the bond failing between the trim tab and the blade. Further, it was proved that the load on the trim tab occurs to peel the tab off from the blade and it is a sufficient supportive load to cause the failure. This stress concentration was observed due to the design failure inherent in itself and the same was proved the by this CFD analysis. Further, the study was extended to
